EMERGENCY ALERT SERVICE BULLETIN

SUBJECT: MAIN ROTOR - Rotor mast

Check of the rotor mast oil pipe
ATA 62

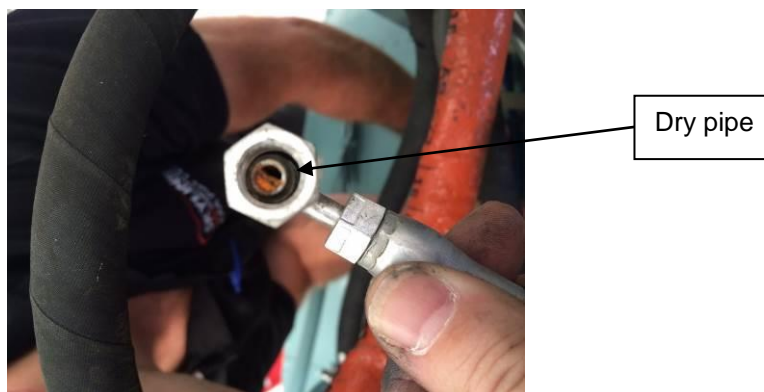
During replacement of a pipe which ensures the lubrication of the rotor mast bearings, this pipe was found to be obstructed. There was no oil on the upper union of the pipe (See photos below).

Analysis revealed that this obstruction is due to a solder run which occurred during soldering of the lower union of the pipe, thus making the oil flow impossible.

The lack of lubrication may affect the operation of the main rotor mast bearings.

Compliance with this ALERT SERVICE BULLETIN consists in ensuring that the main rotor mast lubrication pipe is not obstructed.
